# Reaction Control System Thruster Cracking Consultation: NASA Engineering and Safety Center (NESC) Materials Super Problem Resolution Team (SPRT) Findings

Rebecca A. MacKay  
Glenn Research Center, Cleveland, Ohio

The shuttle orbiter's reaction control system (RCS) primary thruster serial number (S/N) 120 was found to contain cracks in the counter bores and relief radius after a chamber repair and rejuvenation was performed in April 2004. Relief radius cracking had been observed in the 1970s and 1980s in seven thrusters prior to flight; however, counter bore cracking had never been seen previously in RCS thrusters. Members of the Materials Super Problem Resolution Team (SPRT) of the NASA Engineering and Safety Center (NESC) conducted a detailed review of the relevant literature and of the documentation from the previous RCS thruster failure analyses of the 1980s. It was concluded from the review that the previous failure analyses lacked sufficient documentation to support the conclusions that stress corrosion cracking or hot-salt cracking was the root cause of the thruster cracking and lacked reliable inspection controls to prevent cracked thrusters from entering the fleet. The

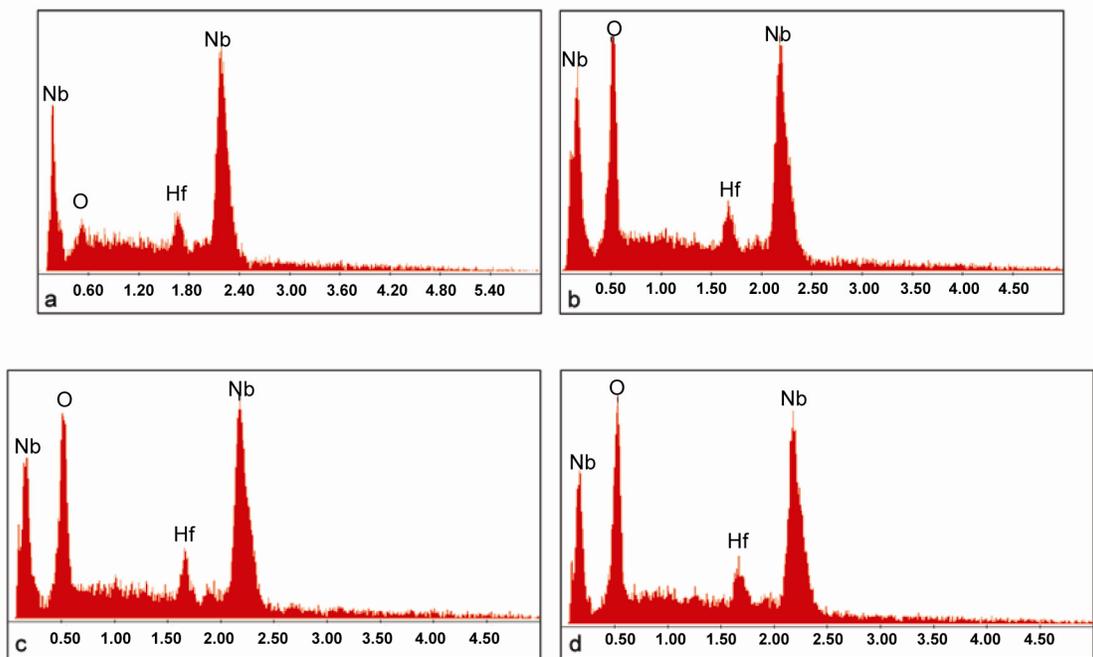
SEM and EDS were performed after each oxidation exposure of 5, 10, 20, 30, 50, and 100 hr at 316 °C (600 °F) to monitor the intergranular surface for possible changes in surface features and chemistry. After each oxidation interval, numerous grain facets on the fracture surface were examined for possible popcorn formation, since grain orientation has been shown to influence subsequent oxidation (ref. 44). Figure 70 shows the same set of grains at a triple point as a function of exposure time at 600 °F. It is evident in the figure that no popcorn or cuboidal oxide formation was observed even after 100 hr at 316 °C (600 °F), which is roughly equivalent to the exposure conditions from two thruster bakeout cycles. Figure 71(a) shows the EDS scan for the starting fracture surface, which is representative of minimally oxidized C-103 material. EDS scans obtained after 10, 50, and 100 hr at 316 °C (600 °F) are displayed in figures 71(b) to (d), respectively, and show that the biggest change in the fracture surface chemistry is observed after 10 hr, where the oxygen peak increased significantly in magnitude. Thus, the sample was oxidizing during the 316 °C (600 °F) exposures, but no other significant changes were evident. The results show that exposure times and temperatures consistent with a double bakeout cycle enable an oxide scale to form on C-103 but are insufficient for popcorn formation. It should be pointed out that the thruster is exposed to the out-gassing of water and carbon dioxide (ref. 55) from the thruster insulation material during the manufacturing bakeout, and this was not being simulated in these laboratory oxidation tests.

Figure 71.—Energy Dispersive Spectroscopy for 316 °C (600 °F) oxidation of C–103 intergranular fracture surfaces as a function of time: (a) 0 hr; (b) 10 hr; (c) 50 hr; and (d) 100 hr. The biggest change in oxygen peak is evident after 10 hr.

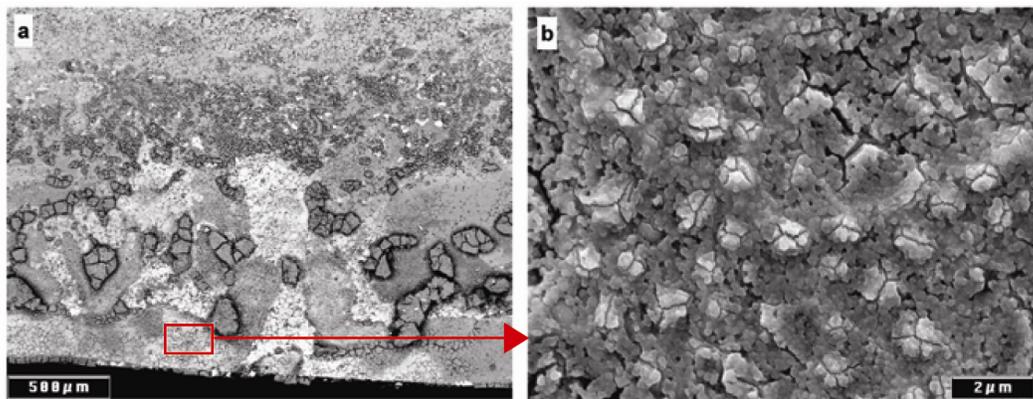
Two polished samples of C-103 were exposed to the preweld etchant consisting of HF, HNO<sub>3</sub>, and H<sub>2</sub>O in equal proportions. While wet, the two samples were laid one on top of the other, forming a “sandwich” specimen with the etchant entrapped. The sandwich was held together with stainless steel wire and dried overnight before an air exposure at 316 °C (600 °F) for 24 hr. The specimen was separated subsequently for examination. Numerous reaction products with different textures and colors were observed with some locations displaying popcorn-like oxidation, as seen in figure 72. The popcorn oxidation was observed in the regions that contained dried HF deposits. Similar tests were conducted with C-103 sandwich specimens at 204, 399, and 816 °C (400, 750, and 1500 °F) for 24 hr in air. The specimens exposed to 204 °C (400 °F) produced oxidized surfaces with small bumps present on the oxide scale; the bumps were similar in size to the popcorn oxidation observed on the thruster hardware, although the bumps did not have the cracked appearance that the popcorn typically exhibited. The bumps appeared to be precursors to the popcorn oxidation, and varied in density across the specimen surfaces. In contrast, the 399 and 816 °C (750 and 1500 °F) exposures produced cracked oxide scales, but neither exposure produced popcorn oxidation. These tests suggest that a narrow range of temperature and the presence of fluorine are required to form popcorn oxidation on C-103. Specifically, for the cracked popcorn to form, it appears that a temperature greater than 204 °C (400 °F) and less than 399 °C (750 °F) are required. These data support the conclusion that the formation of popcorn oxidation on the intergranular cracks in the thruster hardware most likely occurred during the 316 °C (600 °F) manufacturing bakeout cycle.

Figure 72.—Polished C–103 specimen was exposed to HF-containing etchant, which was then entrapped between another piece of C–103 and allowed to dry overnight. The C–103 “sandwich” was heated in air to 316 °C (600 °F) for 24 hr and then separated for examination: (a) C–103 surface showing various surface reaction products; and (b) popcorn features present in rectangle near specimen edge.

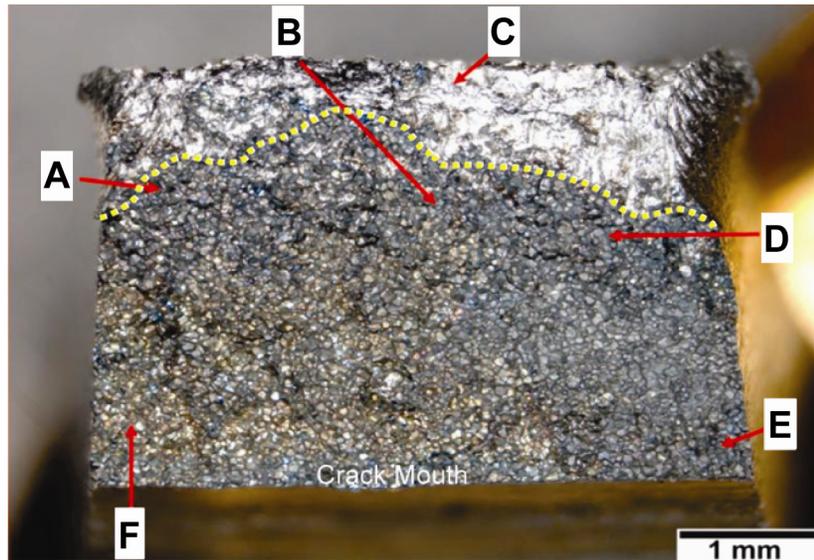
ESCA was performed first on the surface of the relief radius crack near hole L of S/N 120. The original intent was to identify reaction products and determine their distributions across the intergranular fracture surface by taking ESCA scans at multiple locations. Figure 73 shows the fracture surface of this relief radius crack and locations A through F where ESCA analysis was performed. The dotted line superimposed on the image of the fracture surface indicates the approximate locations for the crack tip. Location C represents the lab overload area, whereas the other locations are from the intergranular crack surface. The extremities of the crack surface, as well as areas having different surface colorations, were intentionally selected for analysis, in an effort to determine if the spectra differed as a function of location, thereby indicating possible progression of the crack over time.

Ion-milling was also performed at locations A and B and D to F (fig. 73) to remove surface layers in order to determine depth profiling trends. The maximum sputtering duration was 300 s, which removed about 100 nm of material, and binding energy spectra were obtained during the sputtering operation. It was found that as material was being removed from the fracture surface during sputtering, the peaks associated with the Krytox lubricant were reduced in magnitude, and the peaks corresponding to  $\text{NbO}_2\text{F}$  became more prominent. Carbon was not detected in the subsurface layers corresponding to a depth of 100 nm. These results are consistent with the trends determined from Auger depth profiling (ref. 4) and from the x-ray line scans presented in figure 47. Eventually, as more of the fracture surface material was sputtered away with ion-milling, the resulting ESCA spectra only contained peaks representing niobium oxides. The similarity in the ESCA results obtained before and after ion-milling at various locations on the S/N 120 fracture surface suggests that the IGC was not progressive, which supports the hypothesis that the IGC occurred during manufacturing.

Figure 73.—Intergranular crack from relief radius of hole L from S/N 120. Locations A through F indicate the areas where Electron Spectroscopy for Chemical Analysis was performed. The bright areas near C represent the lab overload region, whereas the duller gray and brown regions represent the intergranular crack surface. Dotted line represents the approximate location for the crack tip.

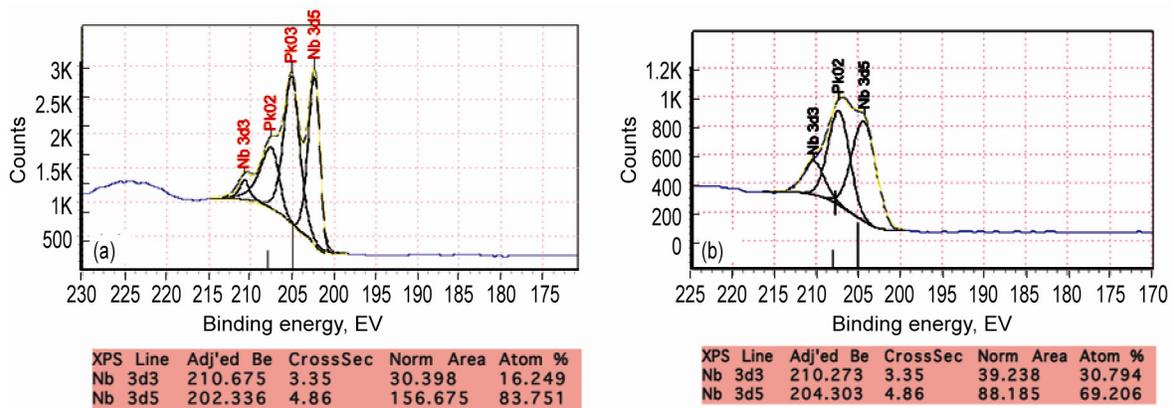
Figure 74(a) shows the ESCA spectra obtained from the lab overload area at location C; it is evident that four peaks are resolved for the spectra. Typical ESCA spectra from metallic niobium surfaces would be expected to show a binding energy doublet, or two peaks of equal magnitude, for Nb 3d<sub>5/2</sub> and 3d<sub>3/2</sub> at 202.0 and 204.7 eV, respectively (ref. 56). As the niobium surface becomes oxidized, the peaks in the spectra shift to higher binding energy values, with the higher oxides (e.g., Nb<sub>2</sub>O<sub>5</sub>) shifting more than the lower oxides (e.g., NbO). Comparison of the binding energy line positions for the peaks in figure 74(a) to reference spectra in the literature (refs. 56 and 57) for niobium, NbO, NbO<sub>2</sub>, and Nb<sub>2</sub>O<sub>5</sub> indicates a close match to niobium metal and Nb<sub>2</sub>O<sub>5</sub>. The two rightmost peaks

in figure 74(a) represent the niobium doublet and the two leftmost peaks represent Nb<sub>2</sub>O<sub>5</sub>. Thus, based on these data, the lab overload area has a slightly oxidized niobium surface.

In contrast, the typical spectra obtained from the intergranular crack surfaces at five locations (A and B and D to F) are shown in figure 74(b), where only three peaks are resolved for those spectra. Comparison of the line positions for the peaks in figure 74(b) to the reference spectra in the literature (refs. 56 and 57) reveals a close match to NbO and Nb<sub>2</sub>O<sub>5</sub>; no metallic niobium doublet is evident. The rightmost peak in the figure represents NbO, the leftmost peak represents Nb<sub>2</sub>O<sub>5</sub>, and the middle peak has the highest magnitude from the overlap of additional peaks from NbO and Nb<sub>2</sub>O<sub>5</sub>. The spectra in figure 74(b) are typical for more heavily oxidized surfaces that contain a mixture of oxides (ref. 56). Thus, the intergranular crack surface has a thicker and more complex oxide scale than that of the lab overload region. Table VII lists the line positions for the low oxide (NbO) Nb3d<sub>5/2</sub> and for the high oxide (Nb<sub>2</sub>O<sub>5</sub>) Nb3d<sub>3/2</sub> obtained from locations A and B and D to F in S/N 120. It is evident that the line positions were similar across the entire intergranular crack surface from mouth to tip. Additionally, the areas under the peaks for the low and high oxides were integrated, and the resulting percentages of total volume for each oxide on the analyzed surface are also given in table VII. These data indicate that the low oxide, NbO, is consistently the majority phase in the oxide scale of the intergranular crack surface. Thus, the same oxides were found in approximately the same volume fraction across the fracture surface, which provides further evidence that the intergranular thruster cracks did not form progressively over time.

Figure 74.—Electron Spectroscopy for Chemical Analysis spectra obtained from intergranular crack region from relief radius of hole L from S/N 120. Niobium region only is shown in (a) spectra from the lab overload at location C from figure 73 and (b) representative spectra of intergranular crack surface from locations A and B and D to F from figure 73.

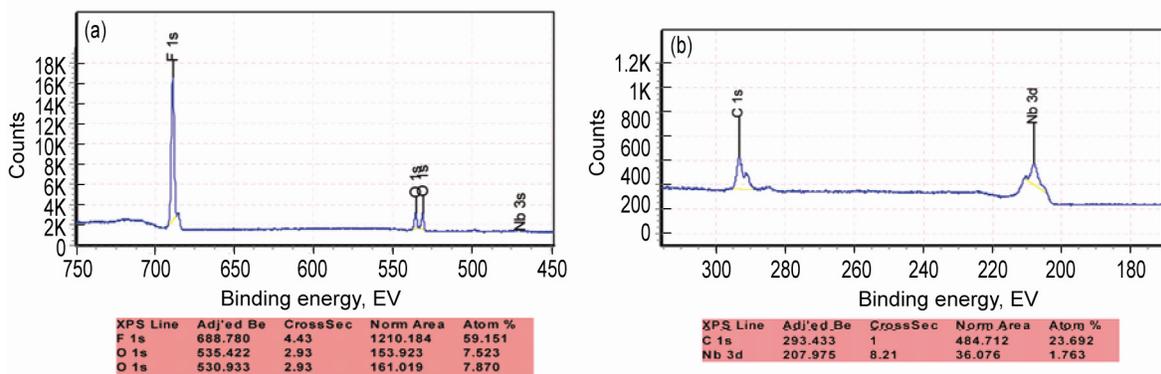
The ESCA spectra from the intergranular crack surfaces revealed the presence of additional peaks that were associated neither with the niobium substrate nor with the above mentioned oxides. Figure 75(a) shows spectra containing two peaks for fluorine and for oxygen and multiple small peaks for niobium, and figure 75(b) shows spectra at lower binding energies where three peaks for carbon and for niobium are seen. The rightmost peaks of fluorine and oxygen in figure 75(a) are believed to be associated with NbO<sub>2</sub>F, a reaction product described earlier as resulting from a chemical reaction between NbF<sub>5</sub>, oxygen, and residual moisture in the air (ref. 32). The rightmost carbon peak that is barely above background levels in figure 75(b) is likely the result of contamination from handling. The niobium peaks in figure 75(b) were resolved in figure 74(b) and were described in the previous section.

The remaining peaks for fluorine, oxygen, and carbon in figure 75 were relatively large in magnitude and were found consistently over the analyzed fracture surface of S/N 120; these peaks were not associated with a known reaction product and thus were explored in more detail. A subsequent review of

Figure 75.—Typical Electron Spectroscopy for Chemical Analysis spectra obtained from intergranular crack surface in relief radius near hole L from S/N 120. (a) Spectra containing fluorine (F), oxygen (O), and niobium (Nb) peaks. The left peaks of F and O are from Krytox (DuPont, Wilmington, DE) and the right peaks of F and O are from NbO<sub>2</sub>F. (b) Spectra containing C and Nb peaks. The two left C peaks are from Krytox and the right C peak is from contamination. The three unresolved Nb peaks are from Nb oxides.

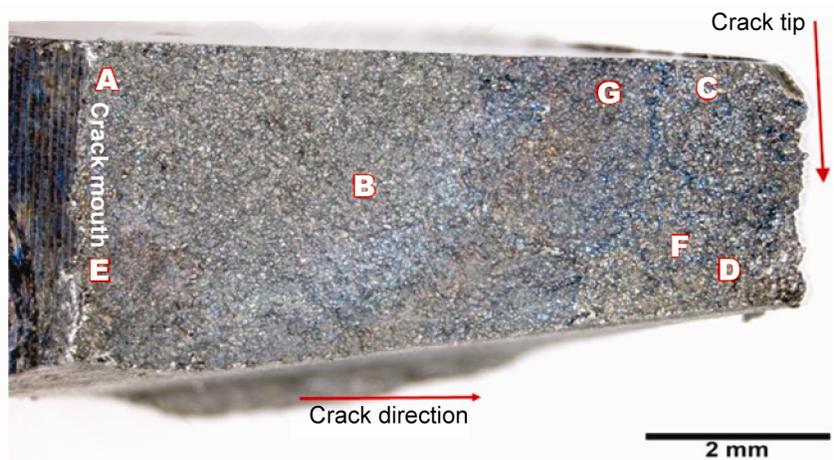
The fracture surface from a relief radius crack near bolt hole B in S/N 132 was also examined by ESCA. This was from a deeper crack than that analyzed in S/N 120, and the location of this cracked section within S/N 132 is illustrated in figure 49. It should be noted that reference 48 incorrectly identified this section as being adjacent to acoustic cavity number 16, when it was actually from the cross-hatched section in figure 49 between acoustic cavity numbers 17 and 18. The fracture surface analyzed from S/N 132 is shown in figure 76, and the specific areas that were analyzed by ESCA are indicated in the figure at locations A to G. The fracture surface is entirely intergranular, and no lab overload region is present in figure 76. Although the entire fracture surface examined in

Figure 76.—Fracture surface of relief radius crack near bolt hole B and between acoustic cavity numbers 17 and 18 from S/N 132. (Note, ref. 48 incorrectly identifies this section as being near acoustic cavity number 16.) Locations A through G indicate areas where electron spectroscopy for chemical analysis was performed.
